# Materials for Oxygenated Wastewater Treatment Plant Construction

July 1978

TECHNICAL REPORT DATA (Please read Instructions on the reverse before completing)			
1. REPORT NO. EPA-600/2-78-136		3. RECIPIENT'S ACCESSION NO.	
4. TITLE AND SUBTITLE MATERIALS FOR OXYGENATED WASTEWATER TREATMENT PLANT CONSTRUCTION		5. REPORT DATE July 1978 (Issuing Date)

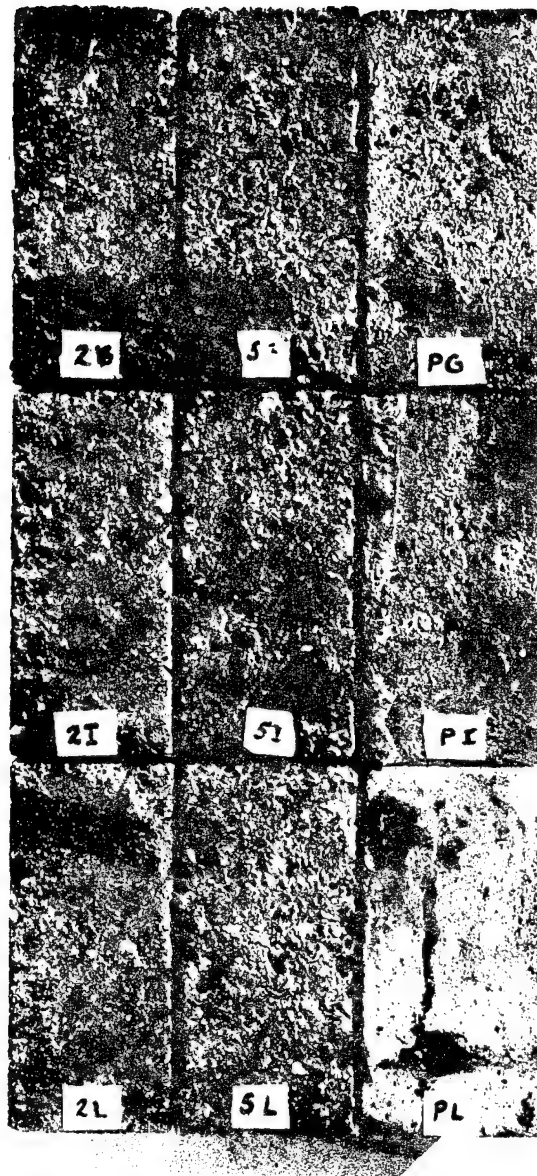
3. Surface conditions. - Generally, only minor changes in surface appearance have occurred at sites 1 and 2. At site 3, erosion of the surface was experienced as shown in figure 15.

a. Concrete made with Type V cement suffered the most severe erosion damage.

b. Less severe erosion damage was observed on concrete made using Type II cement.

Figure 15. - Concrete prisms exposed at site 3 for 28 months depict the damage due to surface abrasion. Prefix of specimen code denotes concrete type, i.e., 2-Type II, 5-Type V, and P-PIC; suffix indicates exposure, i.e., G-gas, I-interface, L-liquor.

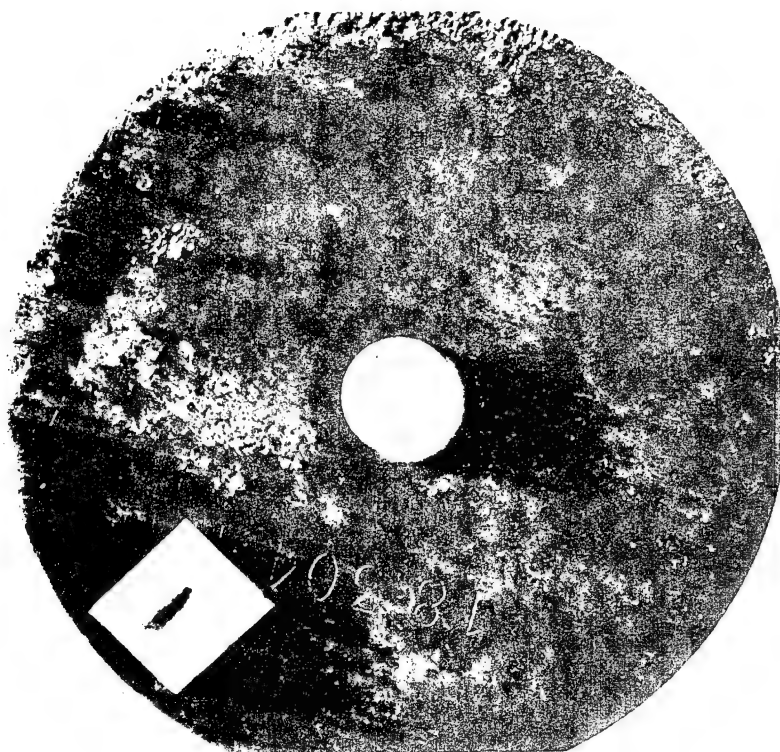
Figure 16. Sensitized Type 304 stainless steel specimen exposed in the gas zone at site 1 for 22 months. Note pitting due to sensitization.

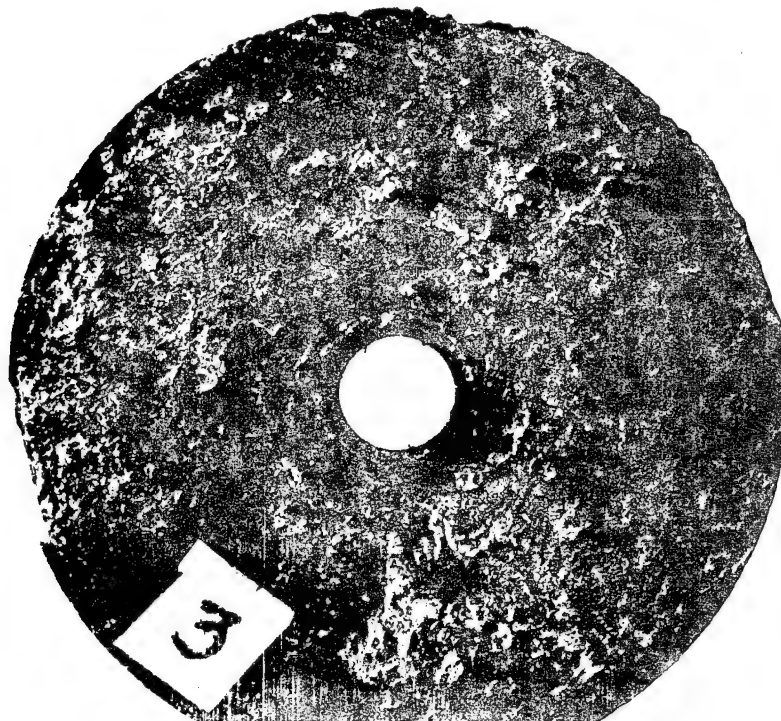
Figure 17. Mild steel specimen exposed in the gas zone at site 2 for 28 months. Surface is deeply pitted.

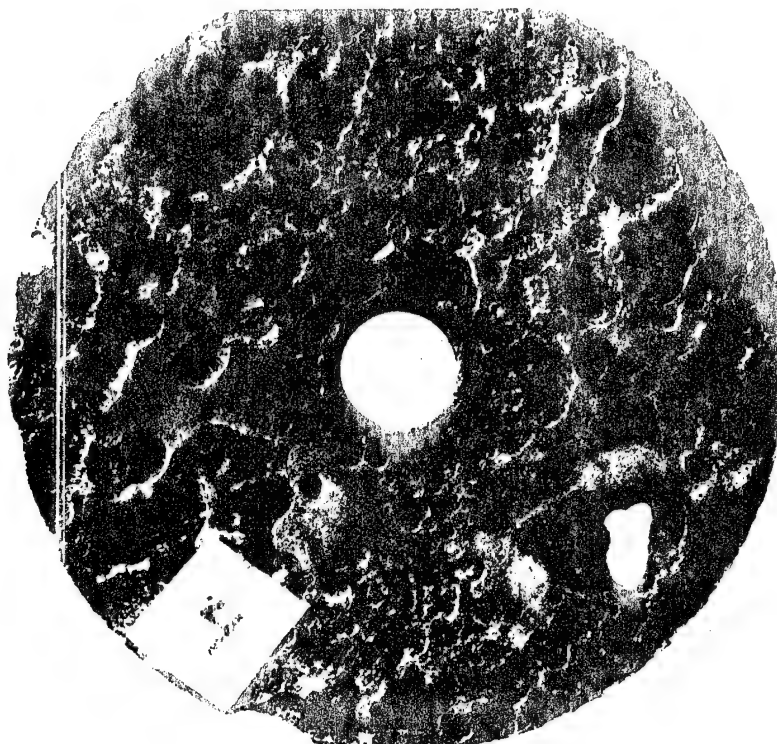
Figure 18. Low alloy steel specimen exposed in the liquor at site 2 for 28 months. Specimen is perforated.

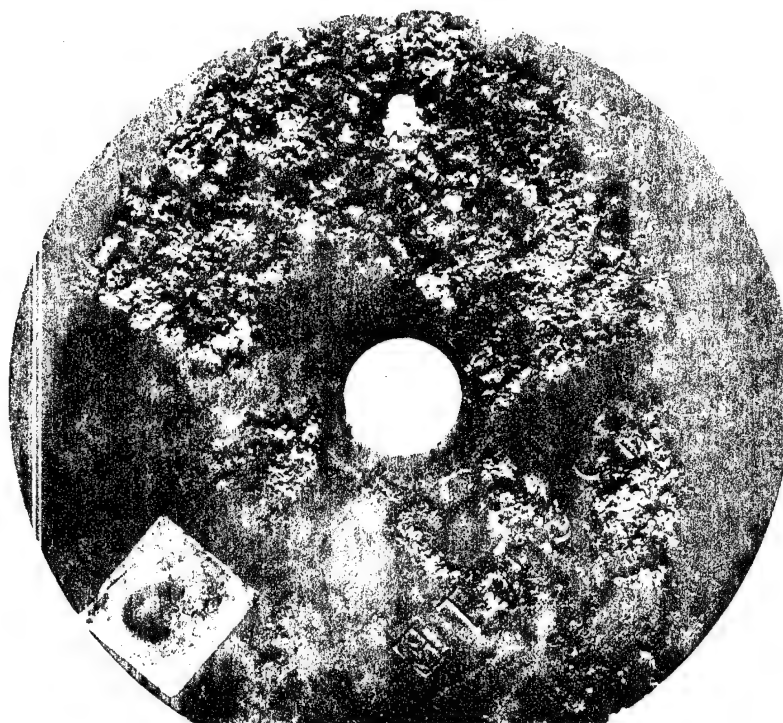
Figure 19. Aluminum alloy 6061 exposed in the gas zone at site 2 for 28 months. Sample is perforated.

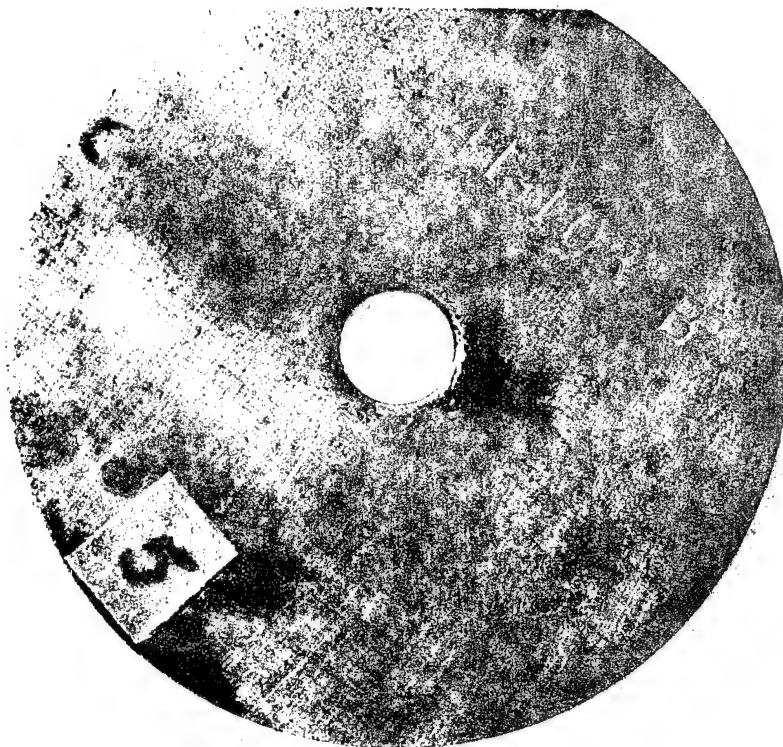
Figure 20. Copper specimen exposed in the gas zone at site 2 for 28 months. Sample is pitted in one localized area only.

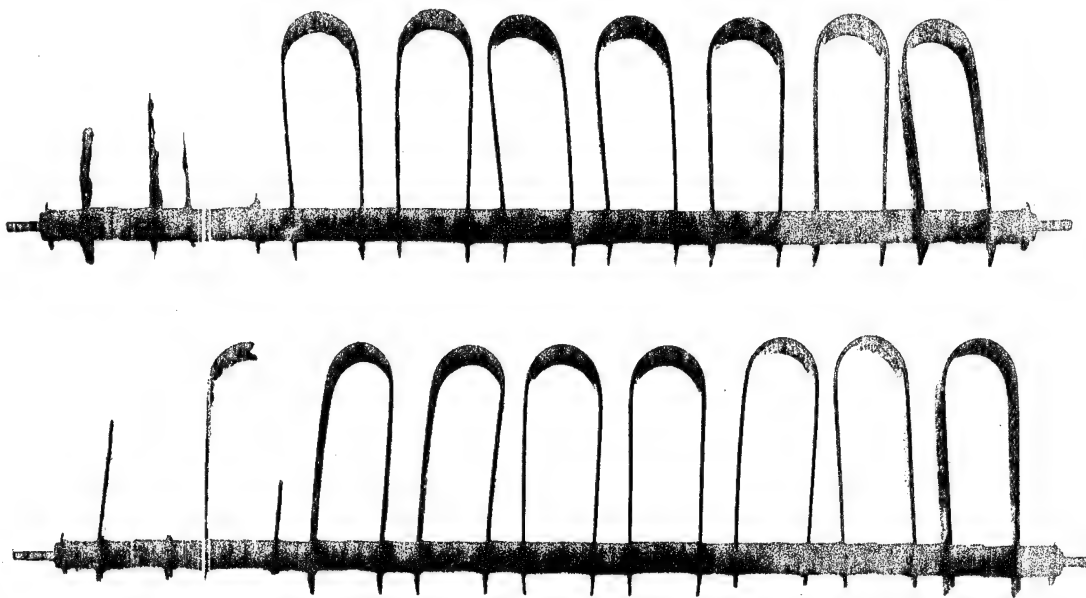
Figure 22. - Duplicate mild steel (top left) and aluminum alloy 6061 (bottom left) stressed specimens failed after 28 months' exposure in the liquor at site 2.

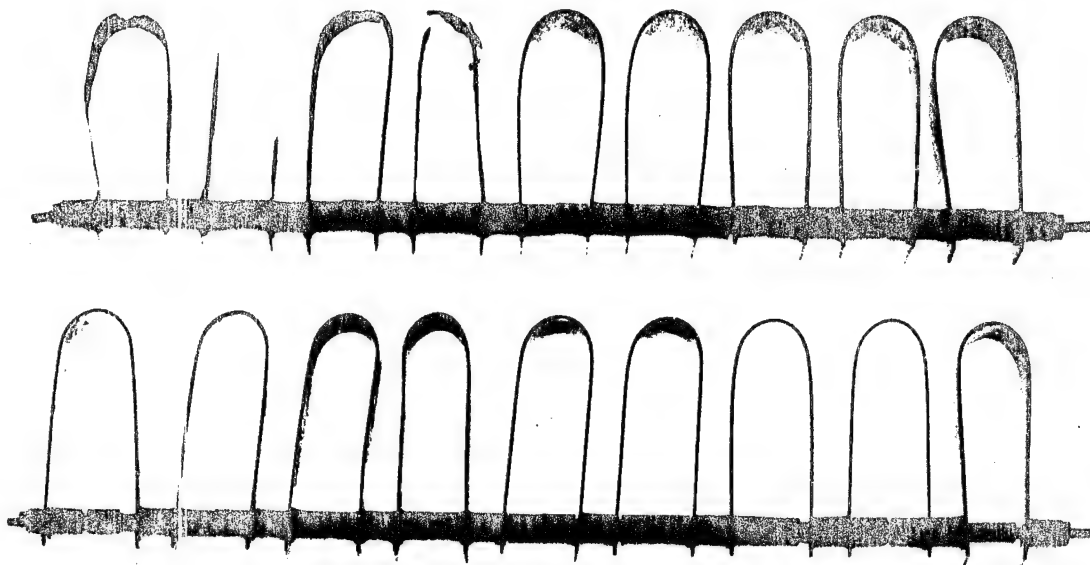
Figure 23. - Duplicate mild steel (first two samples, top row) and low alloy steel (second two samples, top row) stressed specimens failed after 28 months' exposure at the interface at site 3.

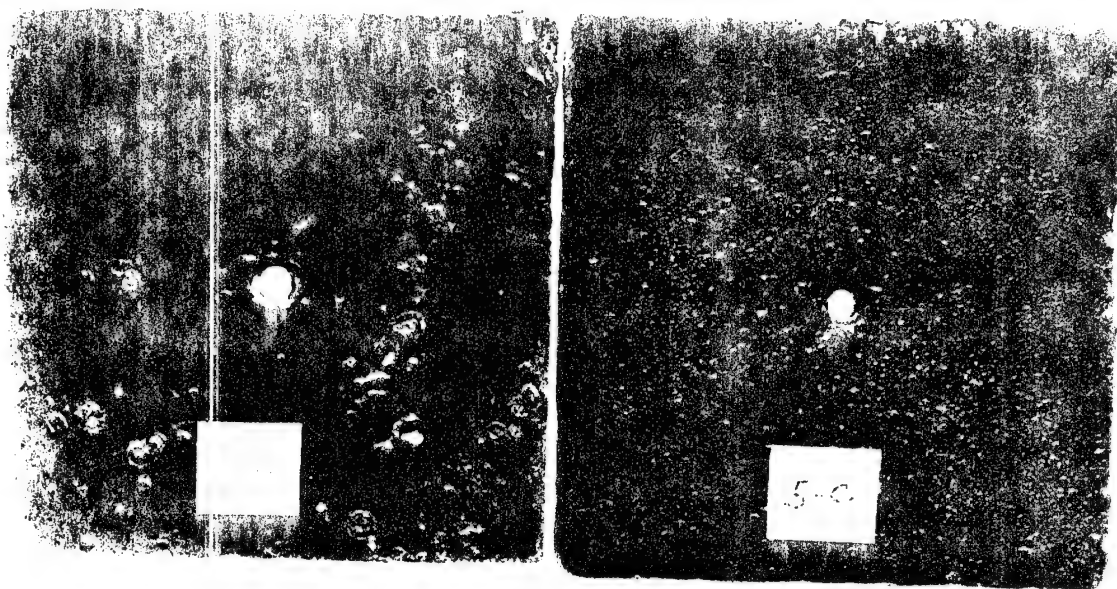
Figure 24. Blistering of proprietary butyl coating (No. C-6) on steel (left) and concrete substrates.

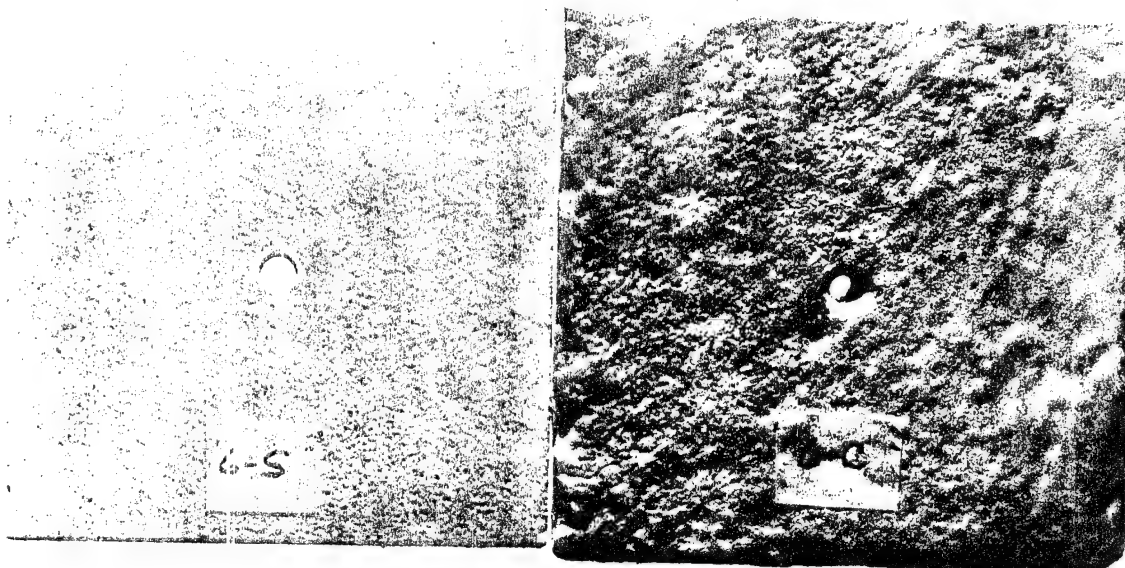
Figure 25. Defect-free proprietary urethane coating (No. C-9) on steel (left) and concrete substrates. Roughness is characteristic of application.

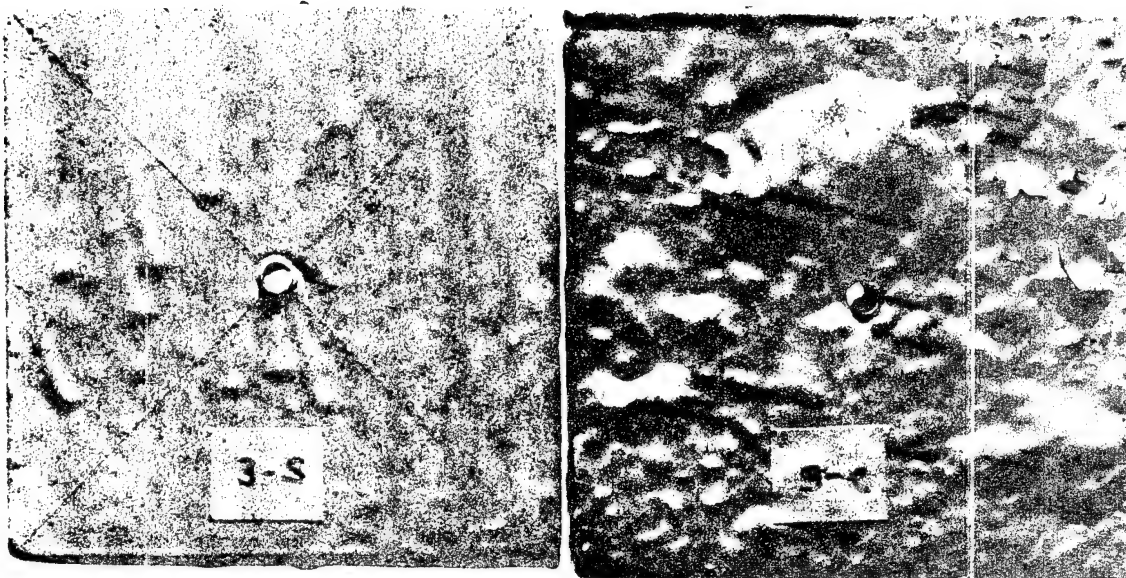
Figure 26. Blistering of proprietary, one-component urethane coating (No. C-13) on steel (left) and concrete substrates.

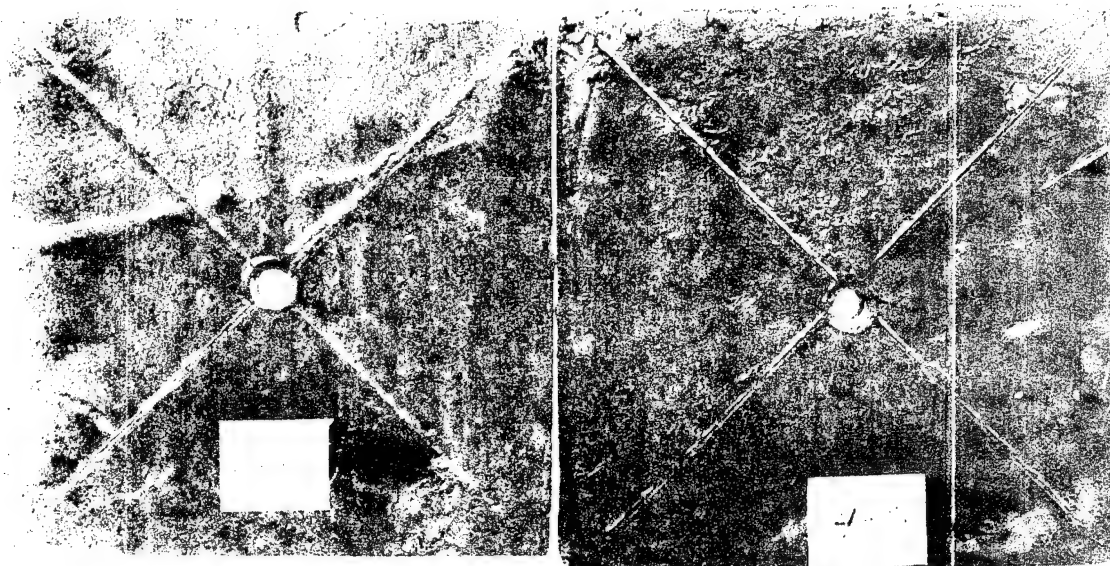
Figure 27. Cracking of coal-tar enamel coating (No. C-3) on steel (left) and on concrete substrates.

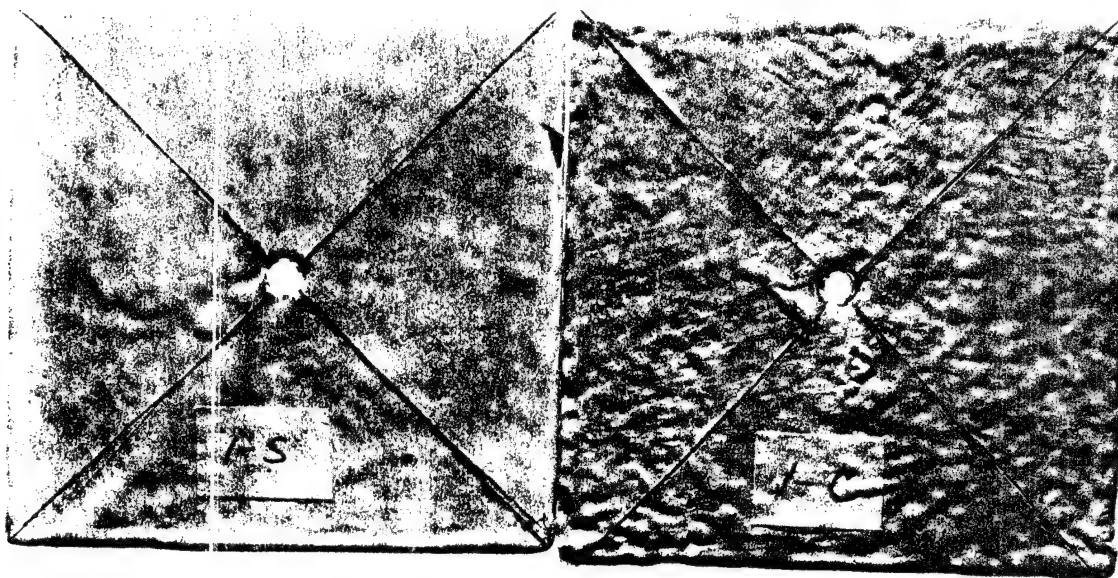
Figure 28. Defect-free phenolic-epoxy coating (No. C-12) on steel (left) and concrete substrates.

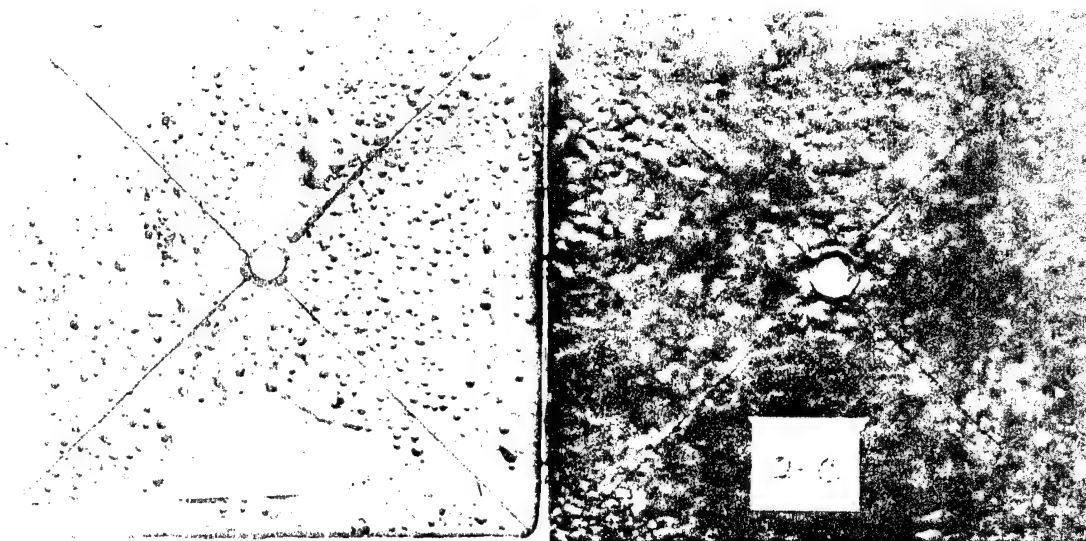
Figure 29. Severely blistered proprietary urethane coating (No. C-14) on steel (left) and concrete substrates.

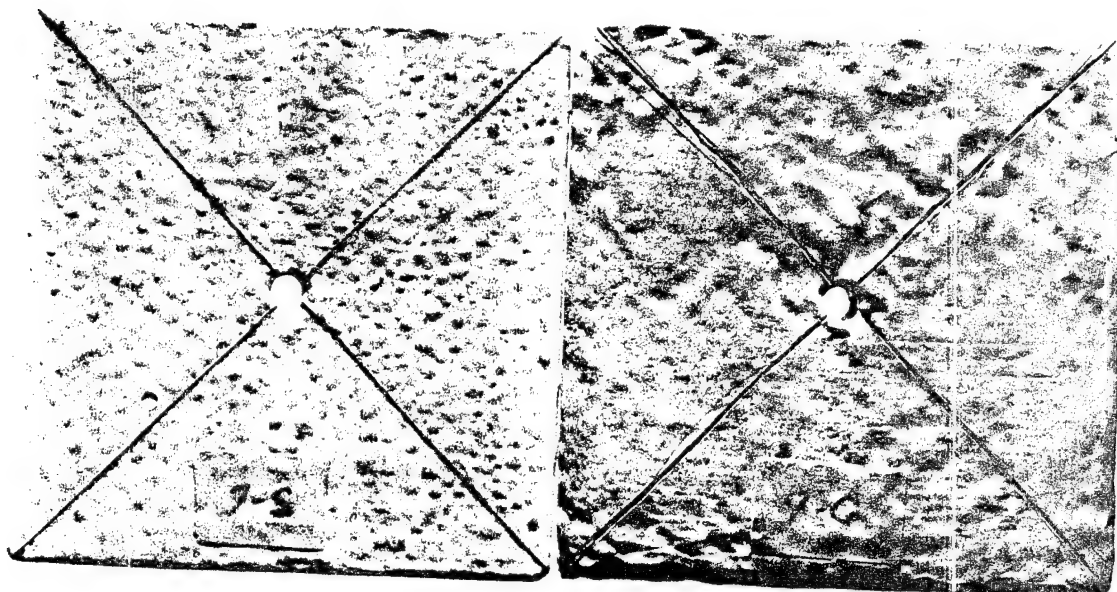
Figure 30. Blistering (topcoat only) of proprietary phenolic-epoxy coating (No. C-16) on steel (left) and concrete substrates.

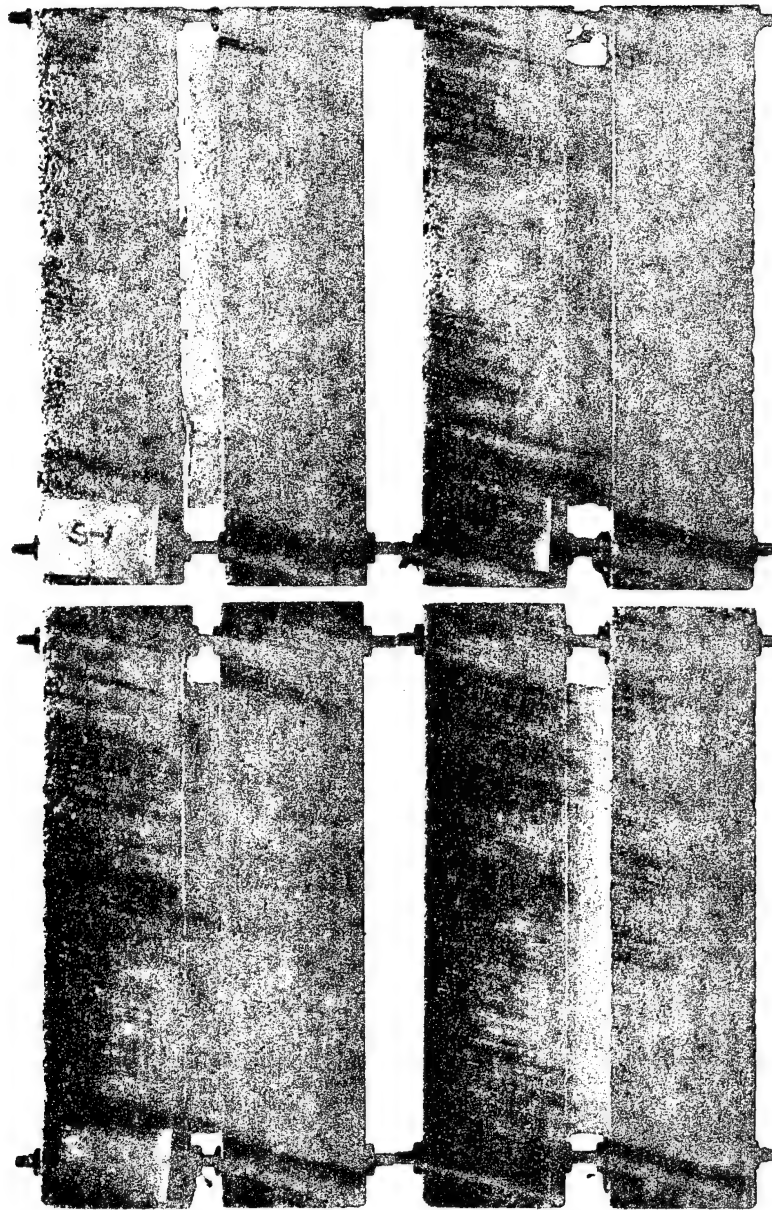
Figure 31. Typical joint sealer performance in these tests. S-1 is a two-component silicone sealant which has incurred bond failure, S-2 and S-3 show surface degradation of two-component polysulfide base material exposed in compressed (S-2) and stretched (S-3) condition and S-4 is intact one-component, low-modulus silicone.
